SITE ASSESSMENT REPORT
FOR
CABOT LANDFILL
CABOT, LONOKE COUNTY, ARKANSAS

June 30, 1994

Subj: Site Assessment: Cabot Landfill
Cabot, Lonoke County, Arkansas
TDD#: T06-9403-015
PAN : EAR0274SAA

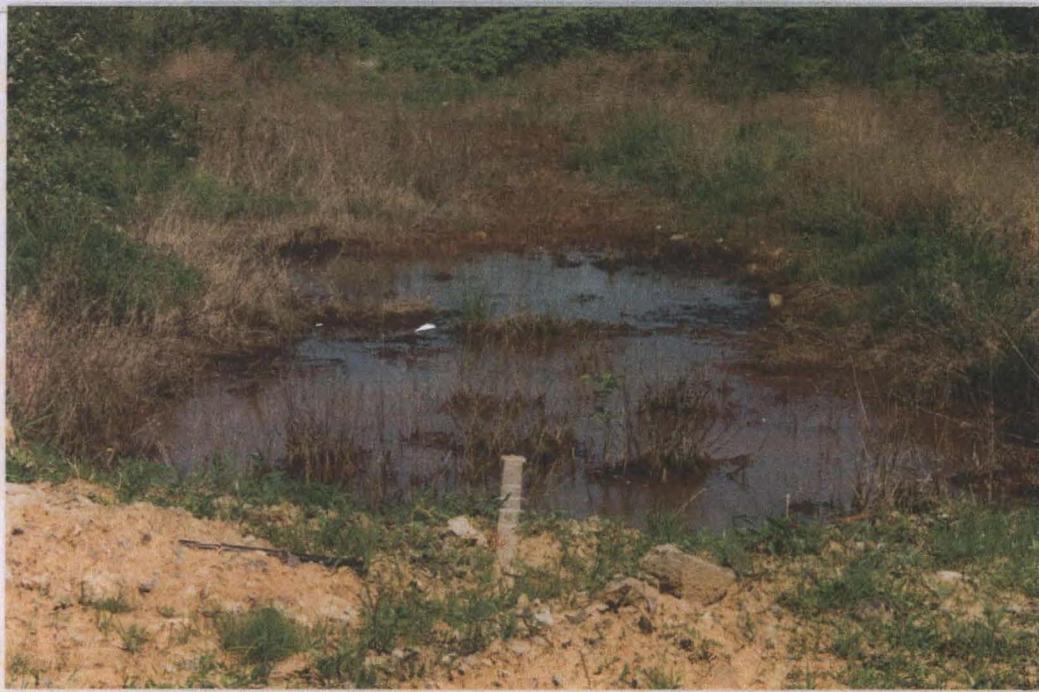
SITE NAME: Cabot Landfill TDD#: T06-9403-015
PHOTO#: 101 PHOTOGRAPHER/WITNESS: DS/EF
DATE: 05/10/94 TIME: 1030 DIRECTION: W
Ponds accumulating along north end of site, near the firing range.

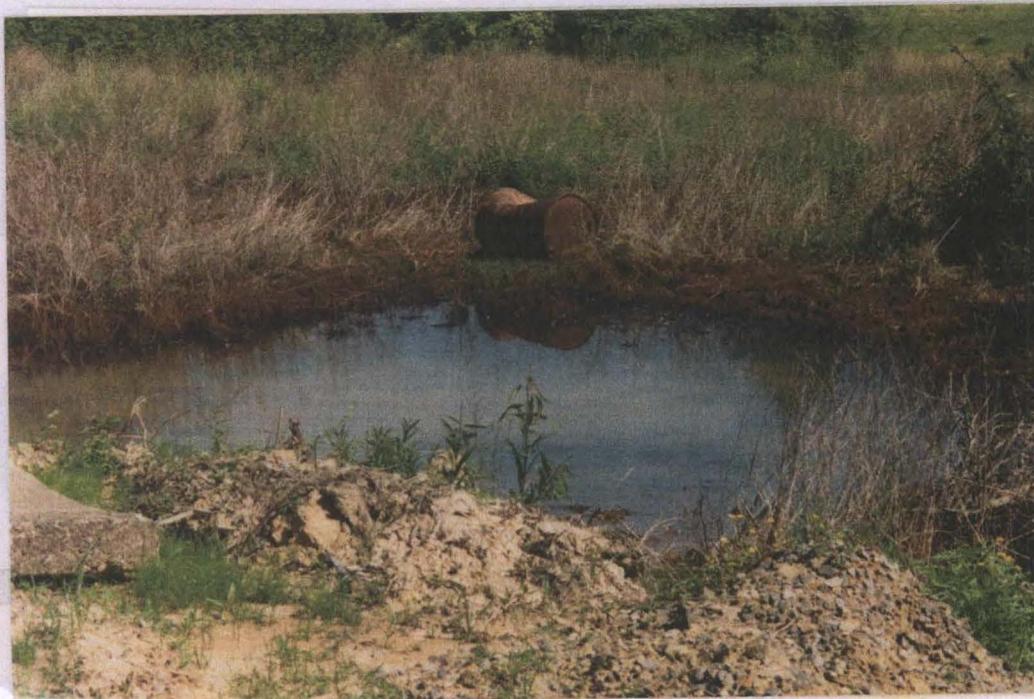
SITE NAME: Cabot Landfill TDD#: T06-9403-015
PHOTO#: 102 PHOTOGRAPHER/WITNESS: DS/EF
DATE: 05/10/94 TIME: 1032 DIRECTION: NW
Pond at north end of site, by the unpermitted 6 acre area.

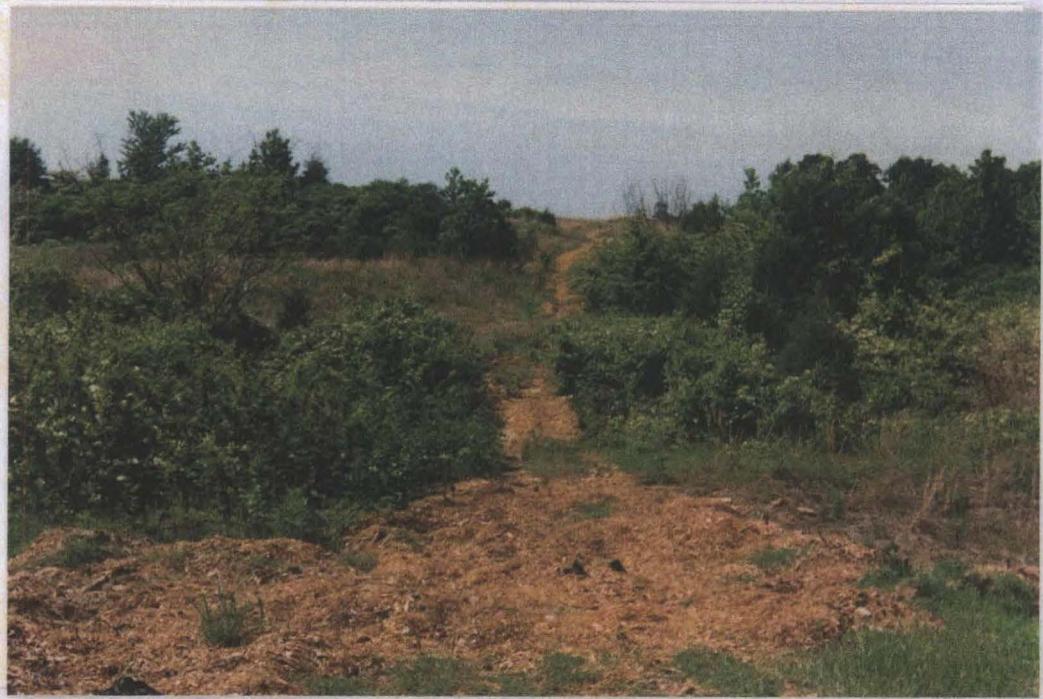
SITE NAME: Cabot Landfill TDD#: T06-9403-015
PHOTO#: 103 PHOTOGRAPHER/WITNESS: DS/EF
DATE: 05/10/94 TIME: 1048 DIRECTION: S
Three-wheeler trail running across the old landfill cell.

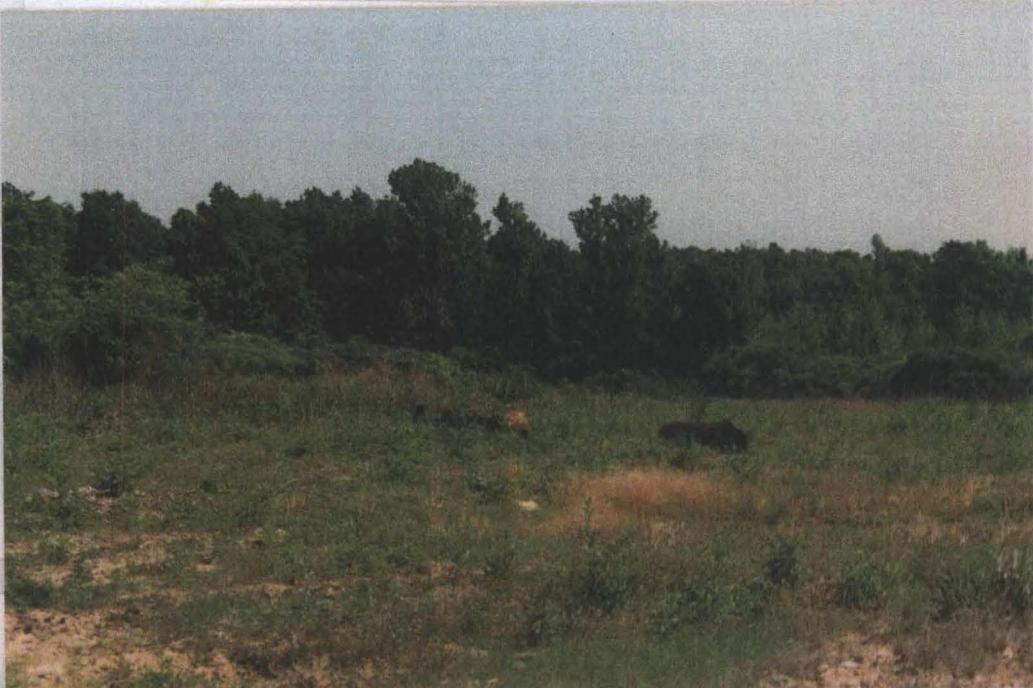
SITE NAME: Cabot Landfill TDD#: T06-9403-015
PHOTO#: 104 PHOTOGRAPHER/WITNESS: DS/EF
DATE: 05/10/94 TIME: 1050 DIRECTION: N
View to north of the old 20 acre cell from the gravel road.

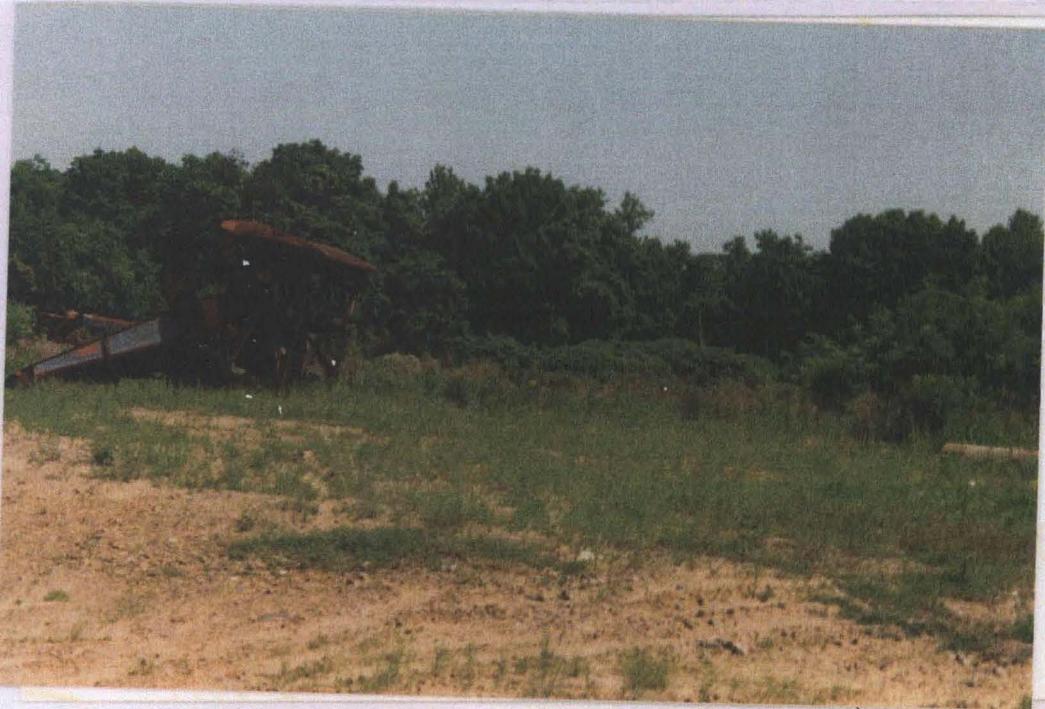
SITE NAME: Cabot Landfill TDD#: T06-9403-015
PHOTO#: 105 PHOTOGRAPHER/WITNESS: DS/EF
DATE: 05/10/94 TIME: 1050 DIRECTION: NW
View to NW from gravel road of old 20 acre cell.

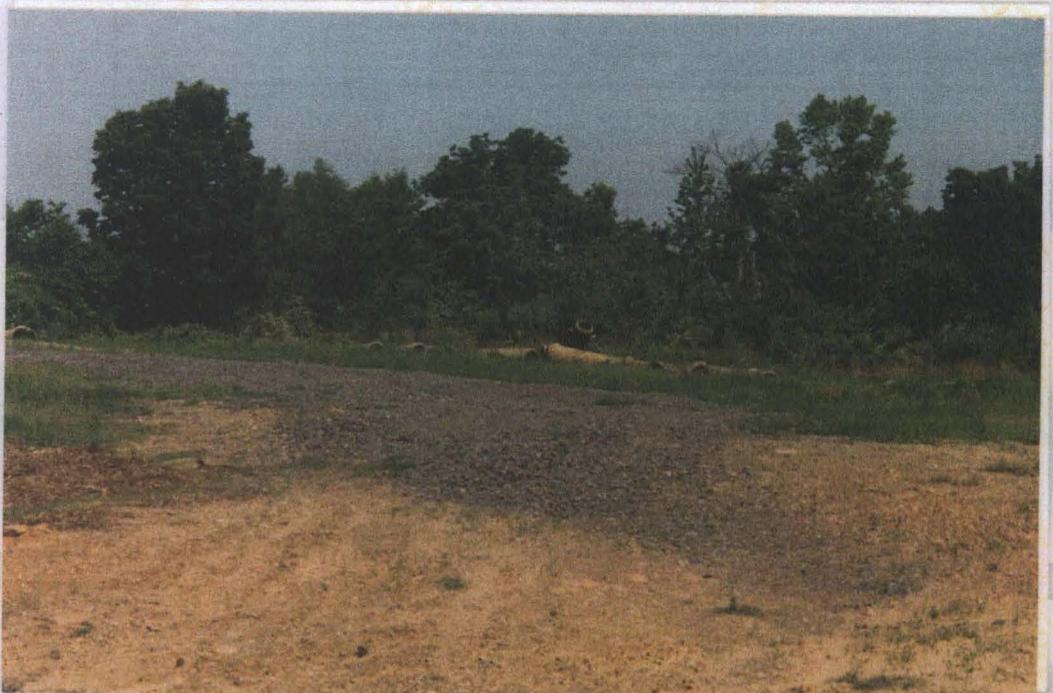
SITE NAME: Cabot Landfill TDD#: T06-9403-015
PHOTO#: 106 PHOTOGRAPHER/WITNESS: DS/EF
DATE: 05/10/94 TIME: 1050 DIRECTION: W
View to west of old cell from gravel road. ↓

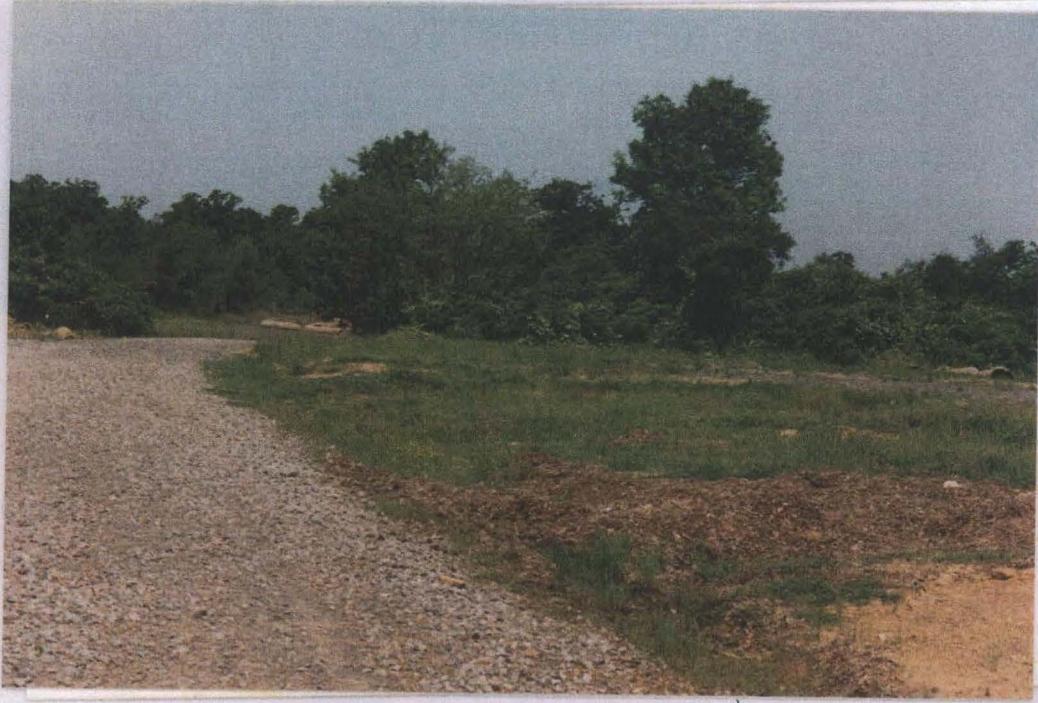
SITE NAME: Cabot Landfill TDD#: T06-9403-015
PHOTO#: 107 PHOTOGRAPHER/WITNESS: DS/EF
DATE: 05/10/94 TIME: 1051 DIRECTION: SW
View of old cell down the gravel road which runs from
the site entrance.

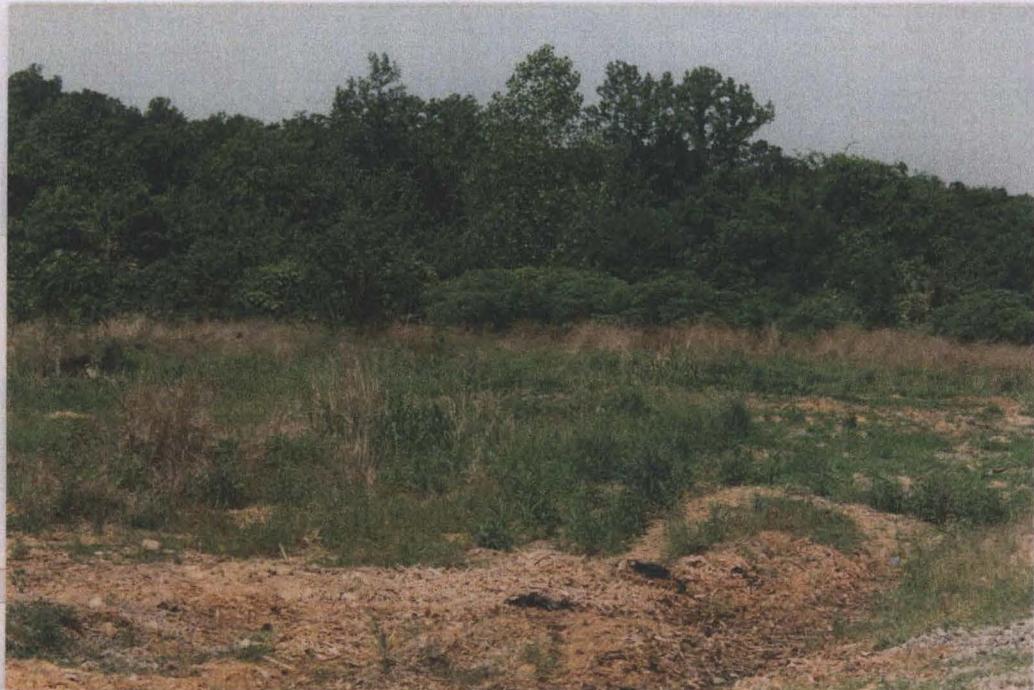
SITE NAME: Cabot Landfill TDD#: T06-9403-015
PHOTO#: 109 PHOTOGRAPHER/WITNESS: DS/EF
DATE: 05/10/94 TIME: 1058 DIRECTION: W
The 6 acre unpermitted cell at the north end of the site.

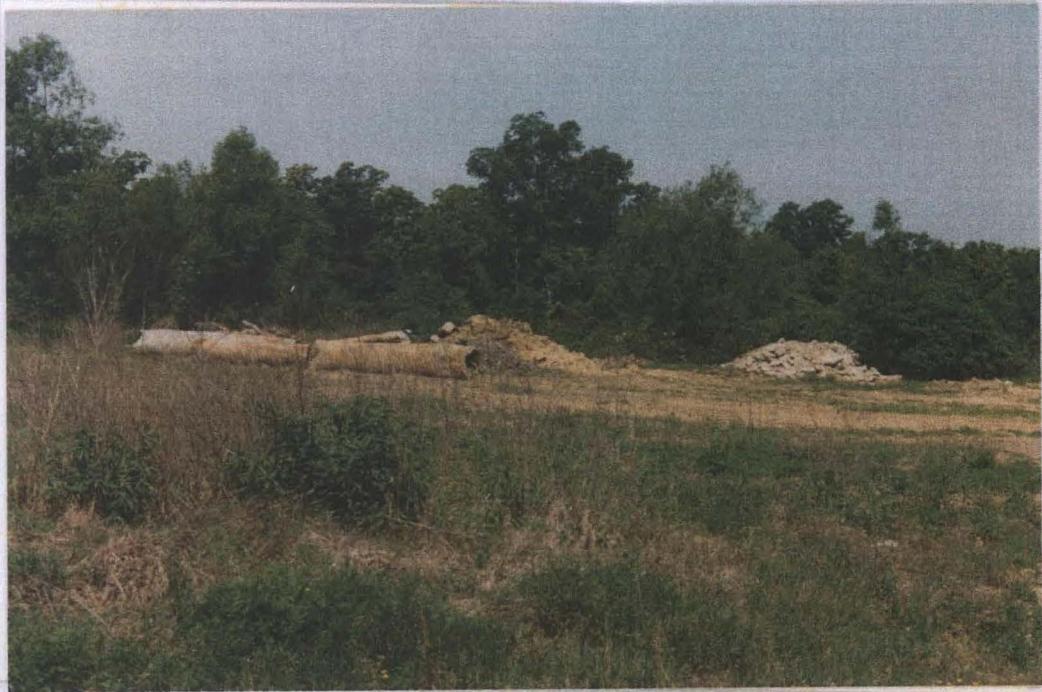
SITE NAME: Cabot Landfill TDD#: T06-9403-015
PHOTO#: 110 PHOTOGRAPHER/WITNESS: DS/EF
DATE: 05/10/94 TIME: 1059 DIRECTION: NW
View down gravel road toward firing range on-site,
near 6 acre cell.

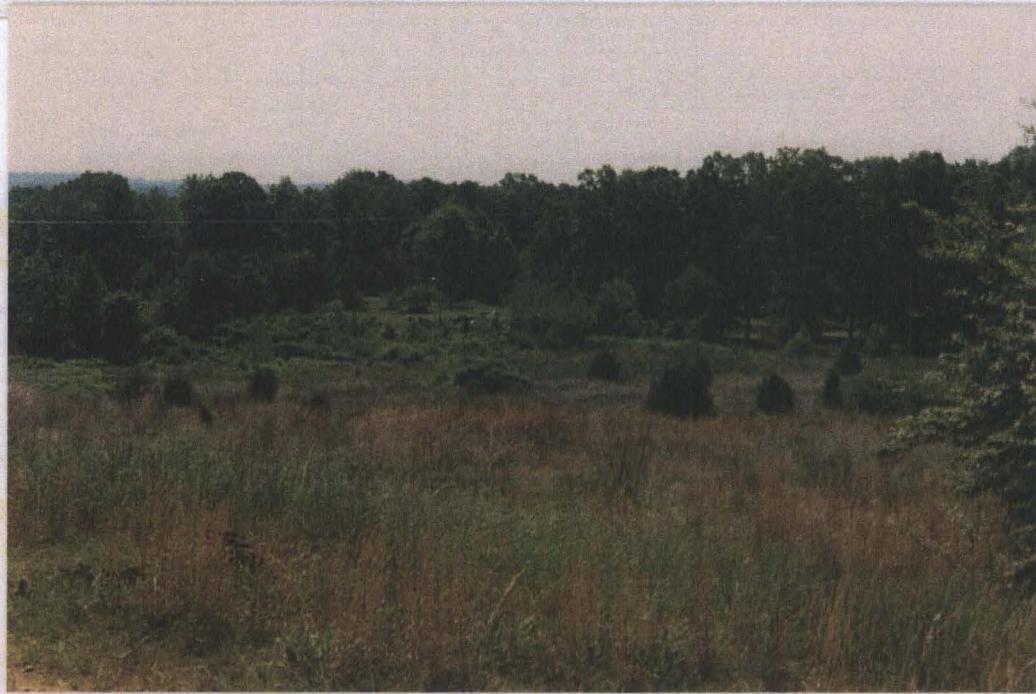
SITE NAME: Cabot Landfill TDD#: T06-9403-015 ↑
PHOTO#: 111 PHOTOGRAPHER/WITNESS: DS/EF
DATE: 05/10/94 TIME: 1110 DIRECTION: N
View from atop the three-wheeler trail and old 20 acre
cell. Four Mile Creek lies 1-2 miles over the
ridge in background.

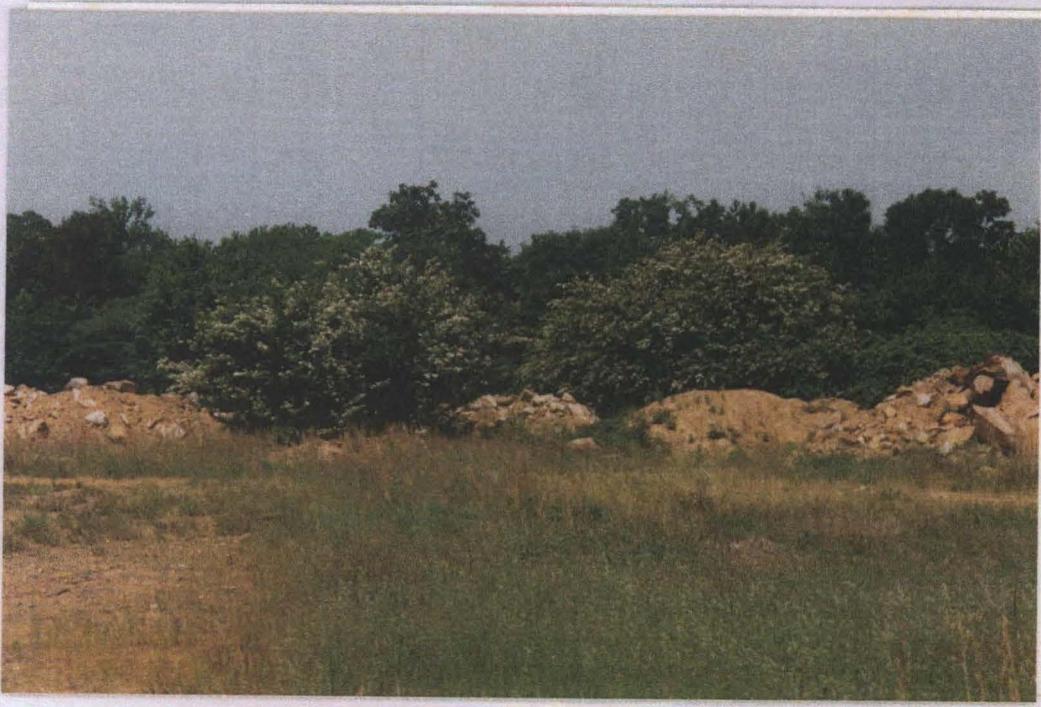
SITE NAME: Cabot Landfill TDD#: T06-9403-015
PHOTO#: 112 PHOTOGRAPHER/WITNESS: DS/EF
DATE: 05/10/94 TIME: 1111 DIRECTION: SE
View from atop old cell toward site entrance and
houses near site. ↓

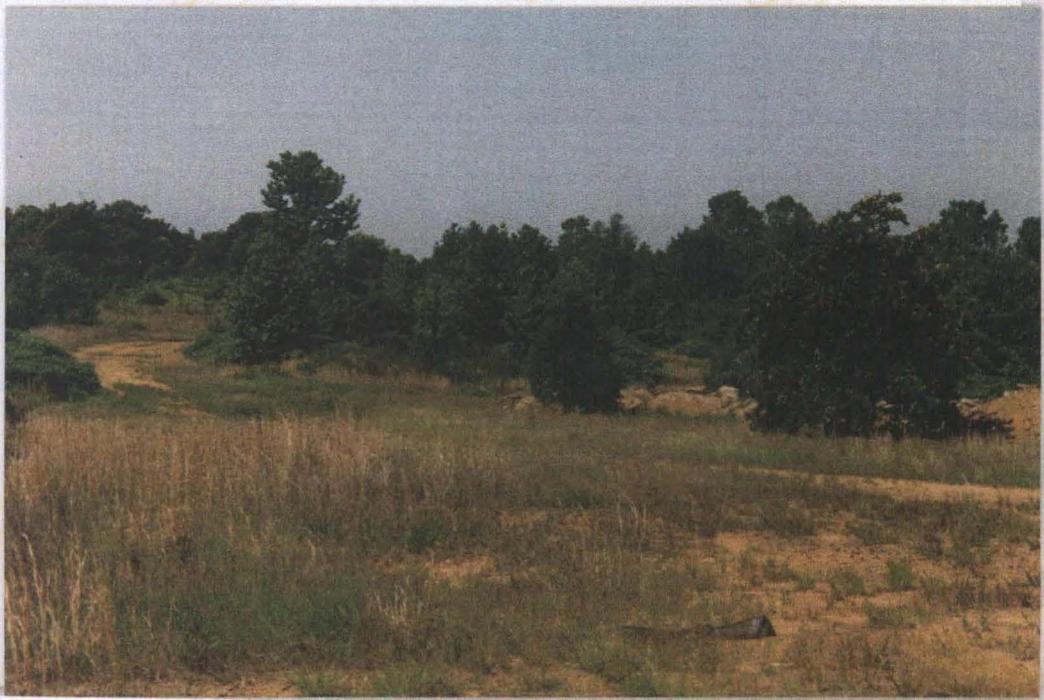
SITE NAME: Cabot Landfill TDD#: T06-9403-015
PHOTO#: 114 PHOTOGRAPHER/WITNESS: DS/EF
DATE: 05/10/94 TIME: 1112 DIRECTION: SW
View atop old cell along continuation of 3-wheeler
trail that bisects site.

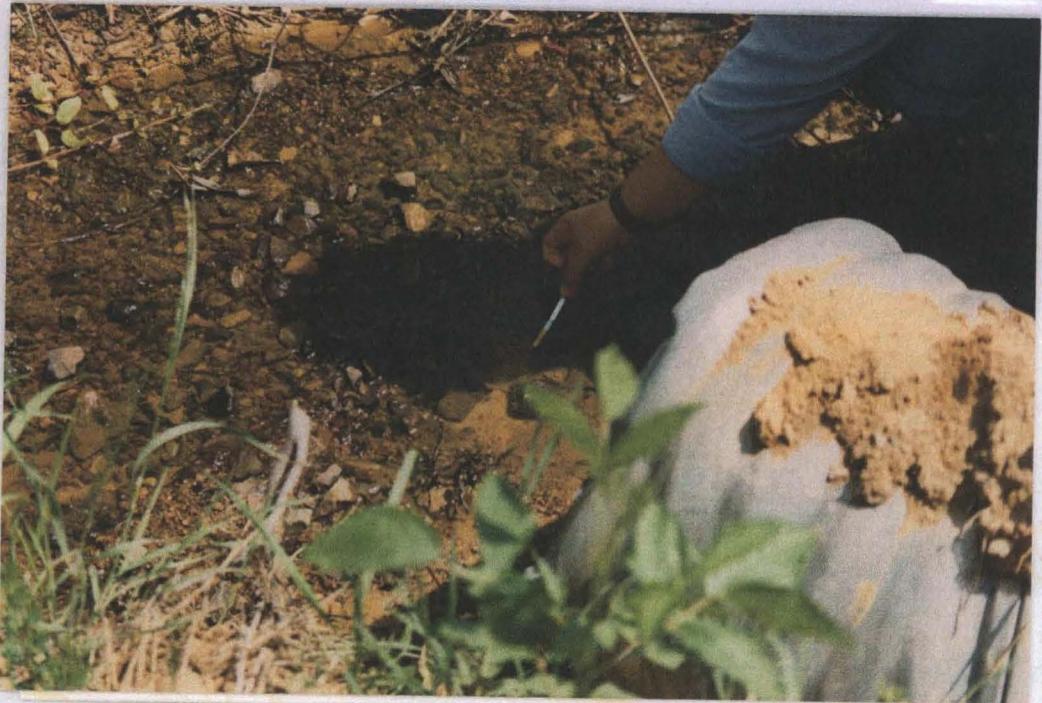
SITE NAME: Cabot Landfill TDD#: T06-9403-015 ↑
PHOTO#: 115 PHOTOGRAPHER/WITNESS: EF/DS
DATE: 05/10/94 TIME: 1128 DIRECTION: Down
pH being taken in ditch near road intersection at SE corner of old cell.

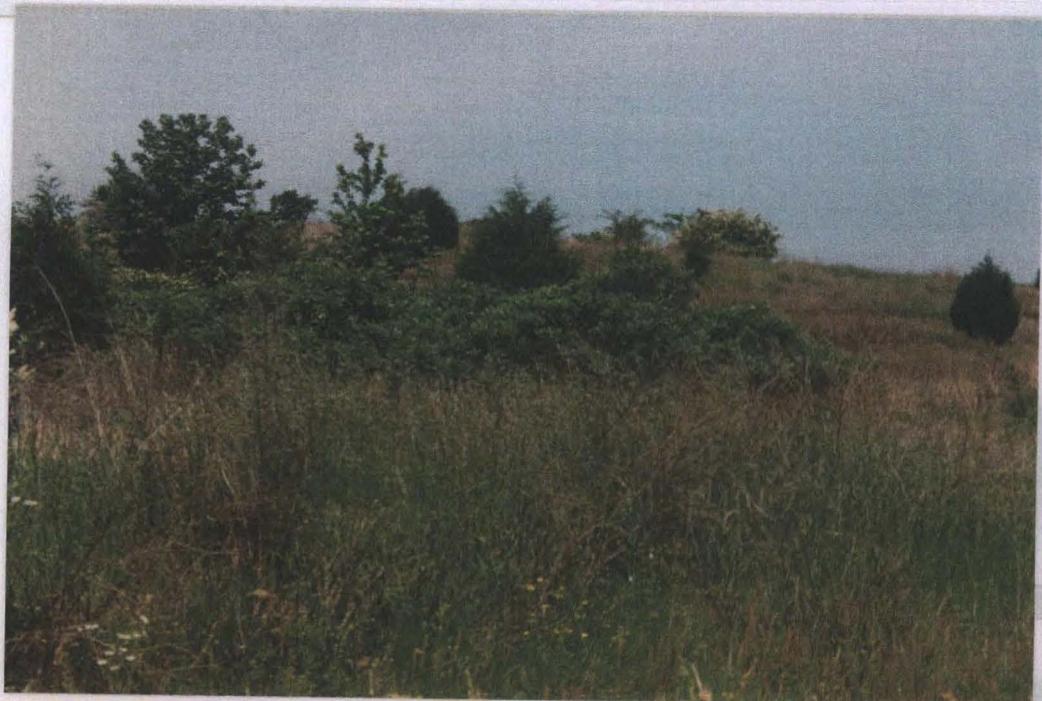
SITE NAME: Cabot Landfill TDD#: T06-9403-015
PHOTO#: 116 PHOTOGRAPHER/WITNESS: EF/DS
DATE: 05/10/94 TIME: 1130 DIRECTION: W
View across old cell from gravel road along SE edge of old cell. ↓

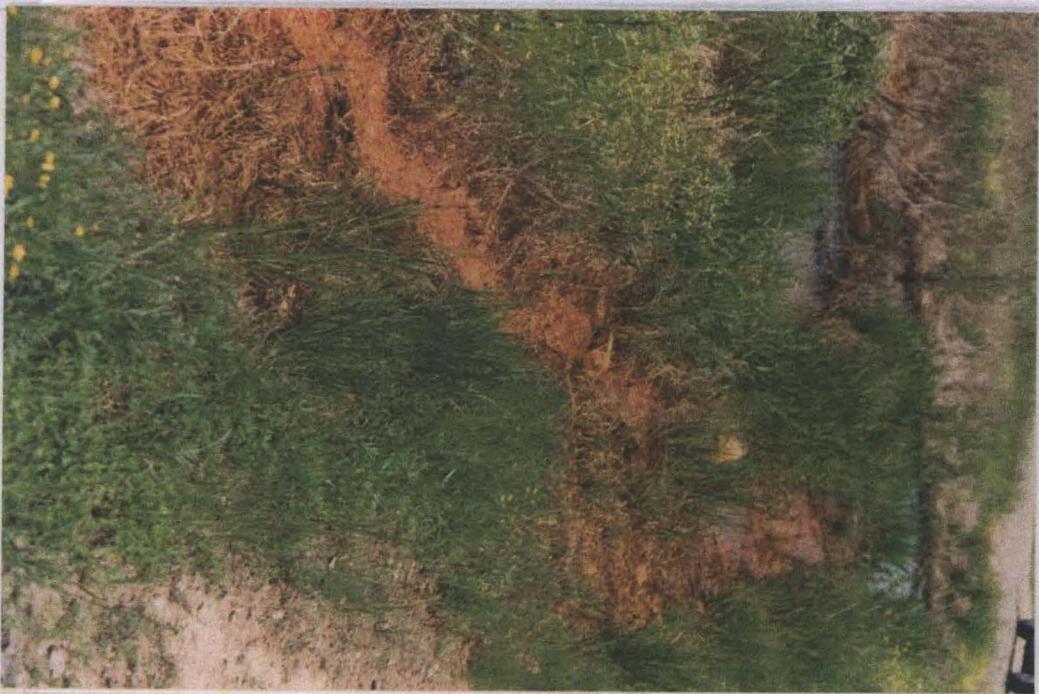
SITE NAME: Cabot Landfill TDD#: T06-9403-015
PHOTO#: 117 PHOTOGRAPHER/WITNESS: EF/DS
DATE: 05/10/94 TIME: 1132 DIRECTION: NW
Ponding in the NE corner of the old cell along the
bend in the gravel road.

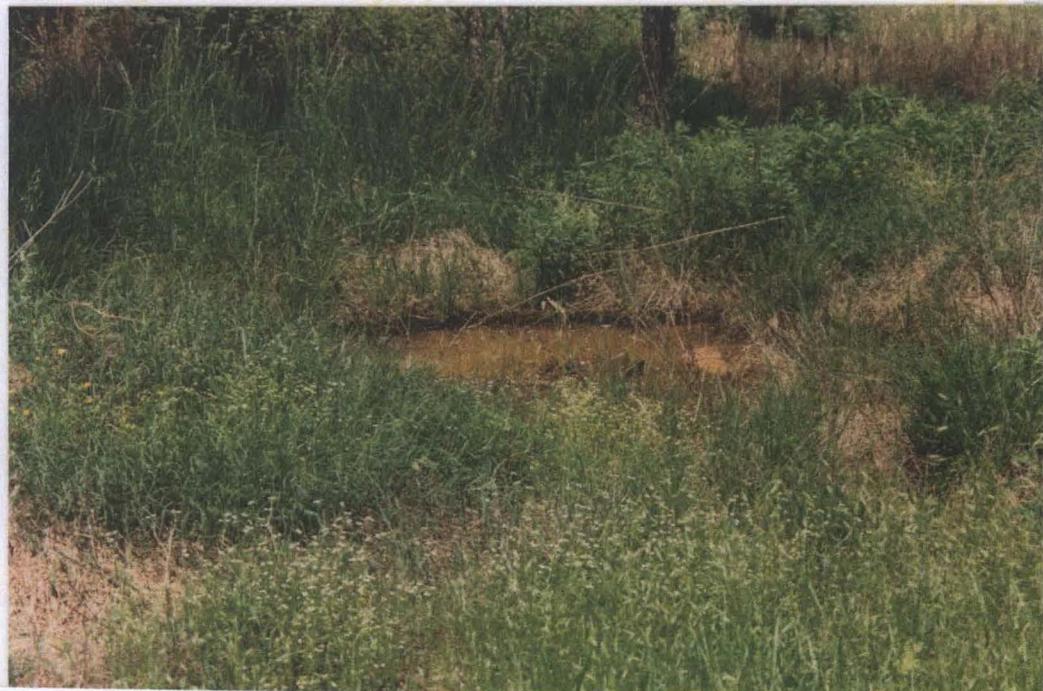
SITE NAME: Cabot Landfill TDD#: T06-9403-015
PHOTO#: 118 PHOTOGRAPHER/WITNESS: EF/DS
DATE: 05/10/94 TIME: 1133 DIRECTION: W
Ponding near NE corner of old cell near bend in gravel
road.

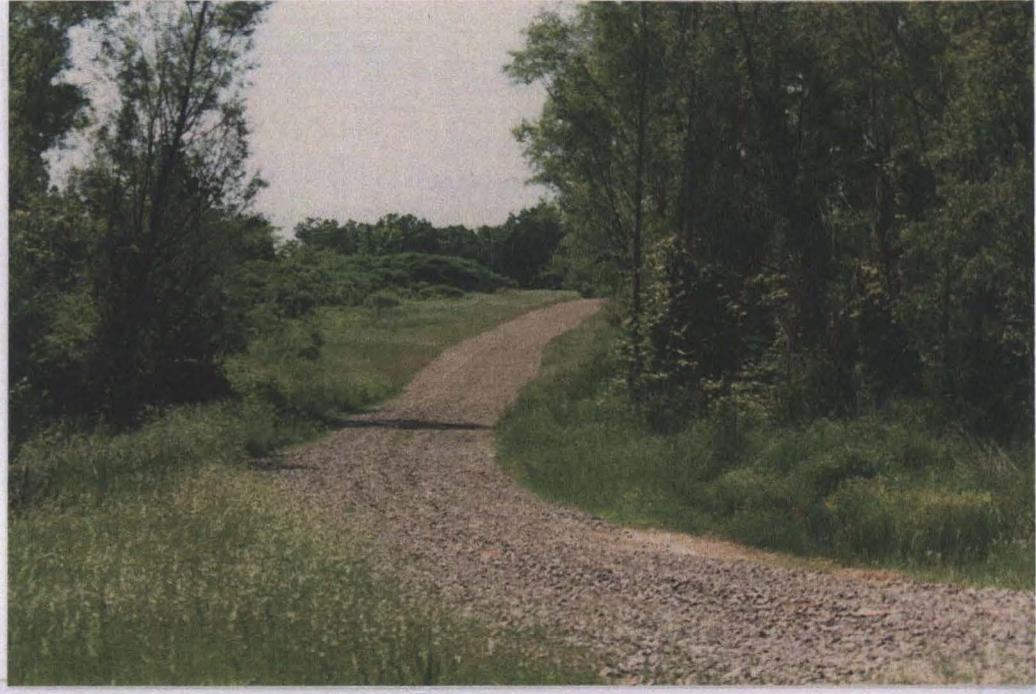
SITE NAME: Cabot Landfill TDD#: T06-9403-015
PHOTO#: 119 PHOTOGRAPHER/WITNESS: EF/DS
DATE: 05/10/94 TIME: 1132 DIRECTION: S
Gravel road (running from site entrance) across SE edge of old cell.

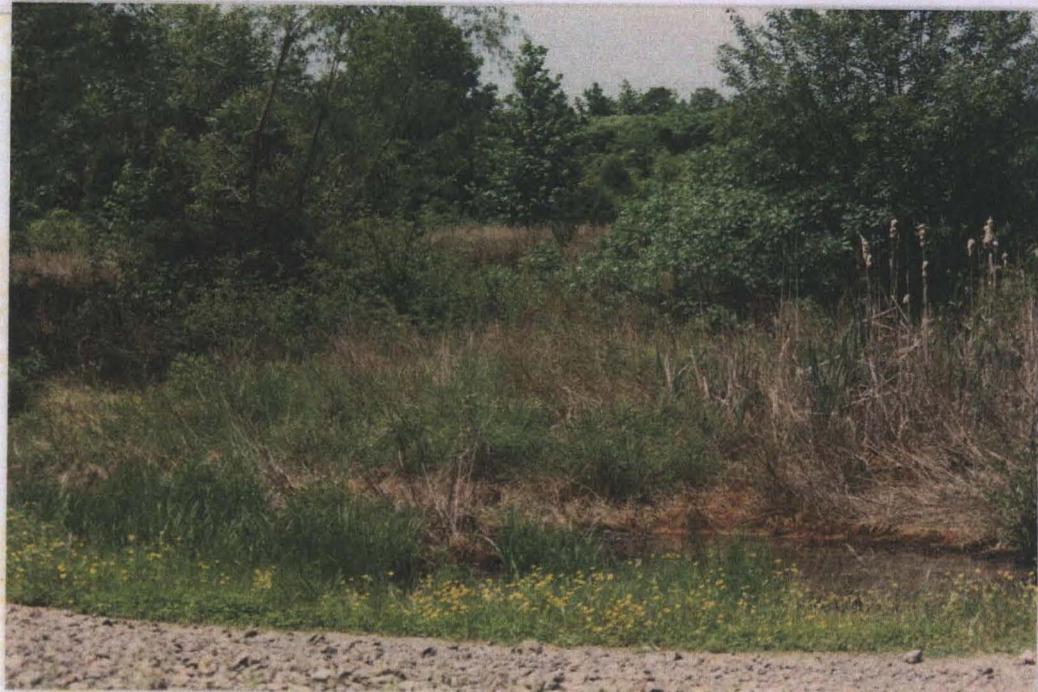
SITE NAME: Cabot Landfill TDD#: T06-9403-015
PHOTO#: 120 PHOTOGRAPHER/WITNESS: EF/DS
DATE: 05/10/94 TIME: 1132 DIRECTION: S
Marshy area (ponding) beside gravel road near NE corner of original cell.

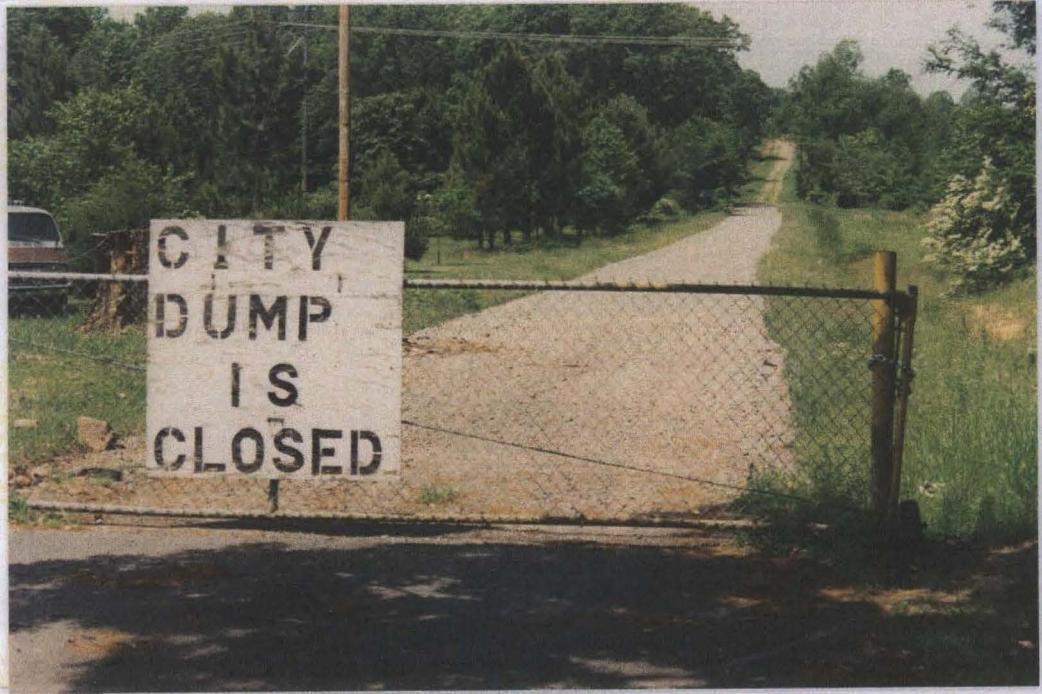
SITE NAME: Cabot Landfill TDD#: T06-9403-015
PHOTO#: 123 PHOTOGRAPHER/WITNESS: EF/DS
DATE: 05/10/94 TIME: 1148 DIRECTION: W
Main entrance gate with "CLOSED" sign.
